TEST REPORT	
	ENVIRONMENTAL	
E	N 60529:1991+A1:2000	0
Report Reference No:	88143-2TRFENV	
Tested by::	Fabio Mauri	
Verified by:	Alessio Pelizzoni	Stems felevour
Date of issue:	2007-06-13	
Testing Laboratory:	Nemko Spa	
Address:	Via del Carroccio 4, I-20046 Bia	assono MI (Italy)
Testing location/ procedure:	Full application of Harmonised Partial application of Harmonise Other standard testing methods Non-standard testing methods SINAL accredited test report	ed standards
Testing location/ address:	Nemko Spa via del Carroccio 4	, I-20046 Biassono MI (Italy)
Applicant's name:	Techno srl	
Address:	via Bancora e Rimoldi , 27- 220	070 Guanzate (CO) Italy
Test specification		
Standard:	EN 60529:1991+A1:2000	
Test procedure:	Nemko WM L0177	
Non-standard test method	N/A	
Test Report Form No:	TRF EN60529	
TRF Originator:	Nemko Spa	
Master TRF:	2005-04	
Nemko Spa, I-20046 Biassono MI, Ita	aly. All rights reserved.	
This publication may be reproduced in who acknowledged as copyright owner and sou assume liability for damages resulting from and context.	rce of the material. Nemko Spa take	es no responsibility for and will not

Test item description:	Connector box system	
Trade Mark:	Techno	
Manu

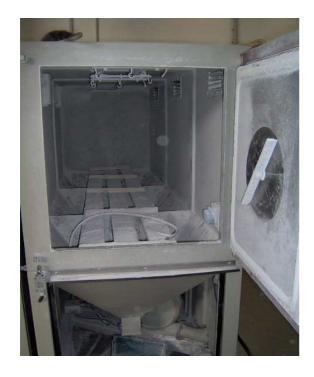
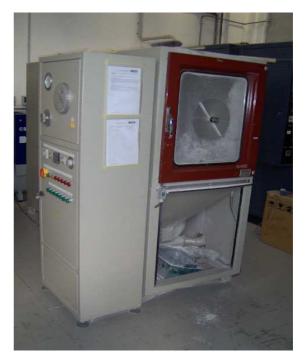
4.1.3 Photo documentation of the test set-up

Typical setup for IP Dust test

Test probe didn't penetrate inside the enclosure.

Dust was not present inside the enclosure and on live parts after test.

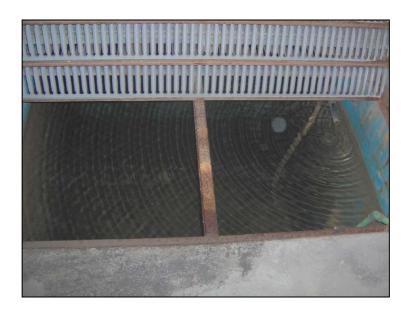
4.1.2 Photo documentation the test set-up

Test duration: 3 h

Depth 5m (above bottom's enclosure)

Water wasn't present inside the enclosure and on live parts after test. (see photos)

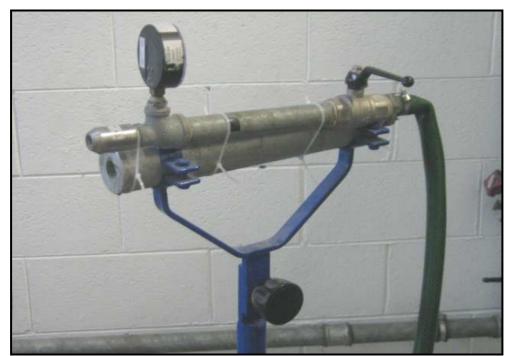
4.3.2 Photo documentation the test set-up

Diameter of nozzle : 12,5mm
Delivery rate : 100l/min
Test duration : 3min.

Snooze for IP X6

Water was not present inside the enclosure and on live parts after test.

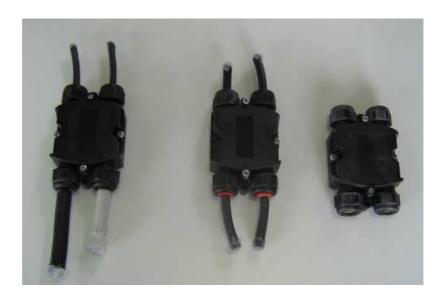
Configuration of sample without cable

E.u.t. general view, same equipment with different section of cable used fort he test Comply with IP66 and IP68
